## Survey Report On

**Murrayfield,  
The Palace,  
Birsay,  
Orkney,  
KW17 2LX.**

**Date of inspection:** 22<sup>nd</sup> August 2024.

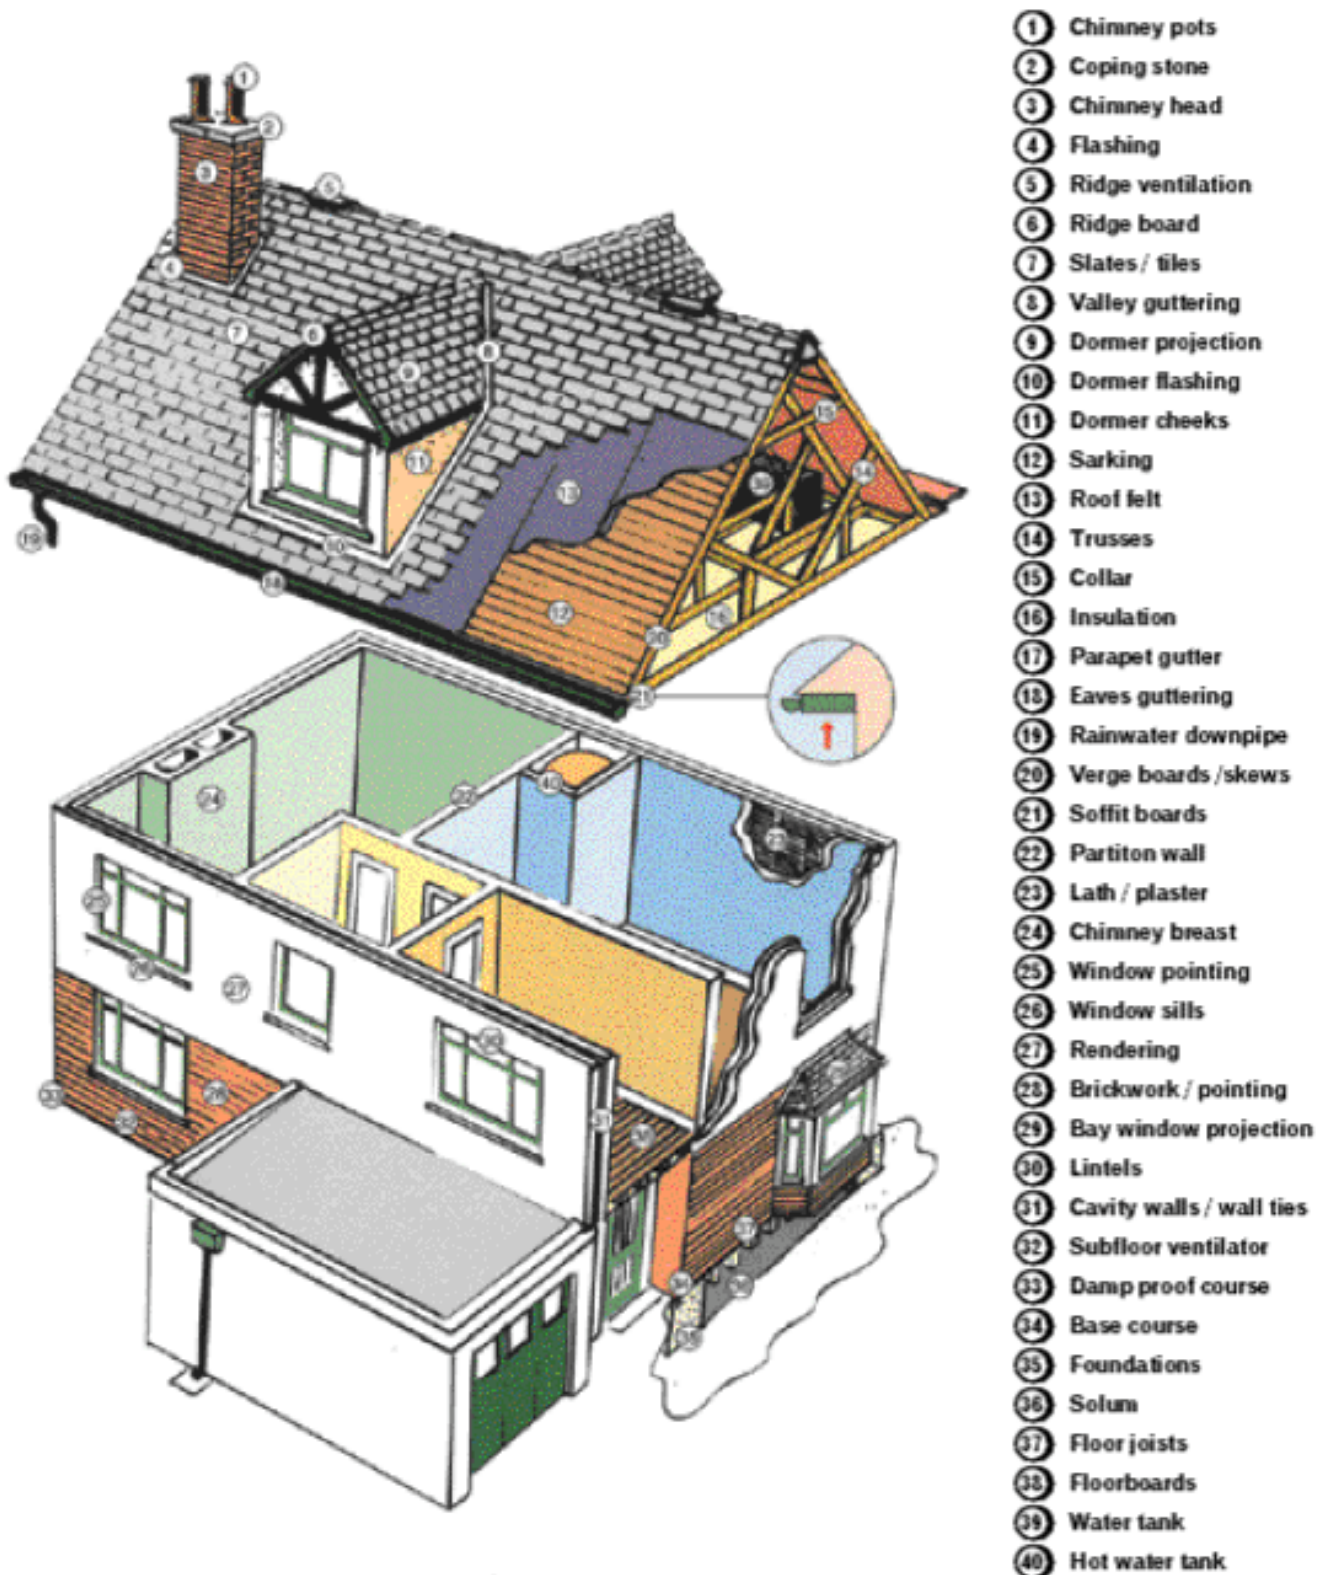
## Sectional diagram showing elements of a typical house

Reference may be made in this report to some or all of the above component parts of the property. This diagram may assist you in locating and understanding these terms.

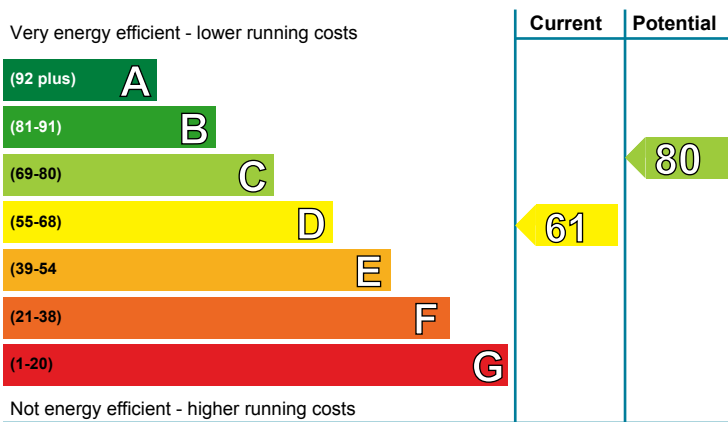
## Energy Efficiency Rating

This graph shows the current efficiency of your home, taking into account both energy efficiency and fuel costs. The higher this rating, the lower your fuel bills are likely to be.

Your current rating is **band D (61)**. The average rating for EPCs in Scotland is **band D (61)**.

The potential rating shows the effect of undertaking all of the improvement measures listed within your recommendations report.
