Survey Report On

Upper Flat,
1c Laing Street,
Kirkwall,
Orkney,
KW15 1NW.

Date of inspection: 3rd December 2024.

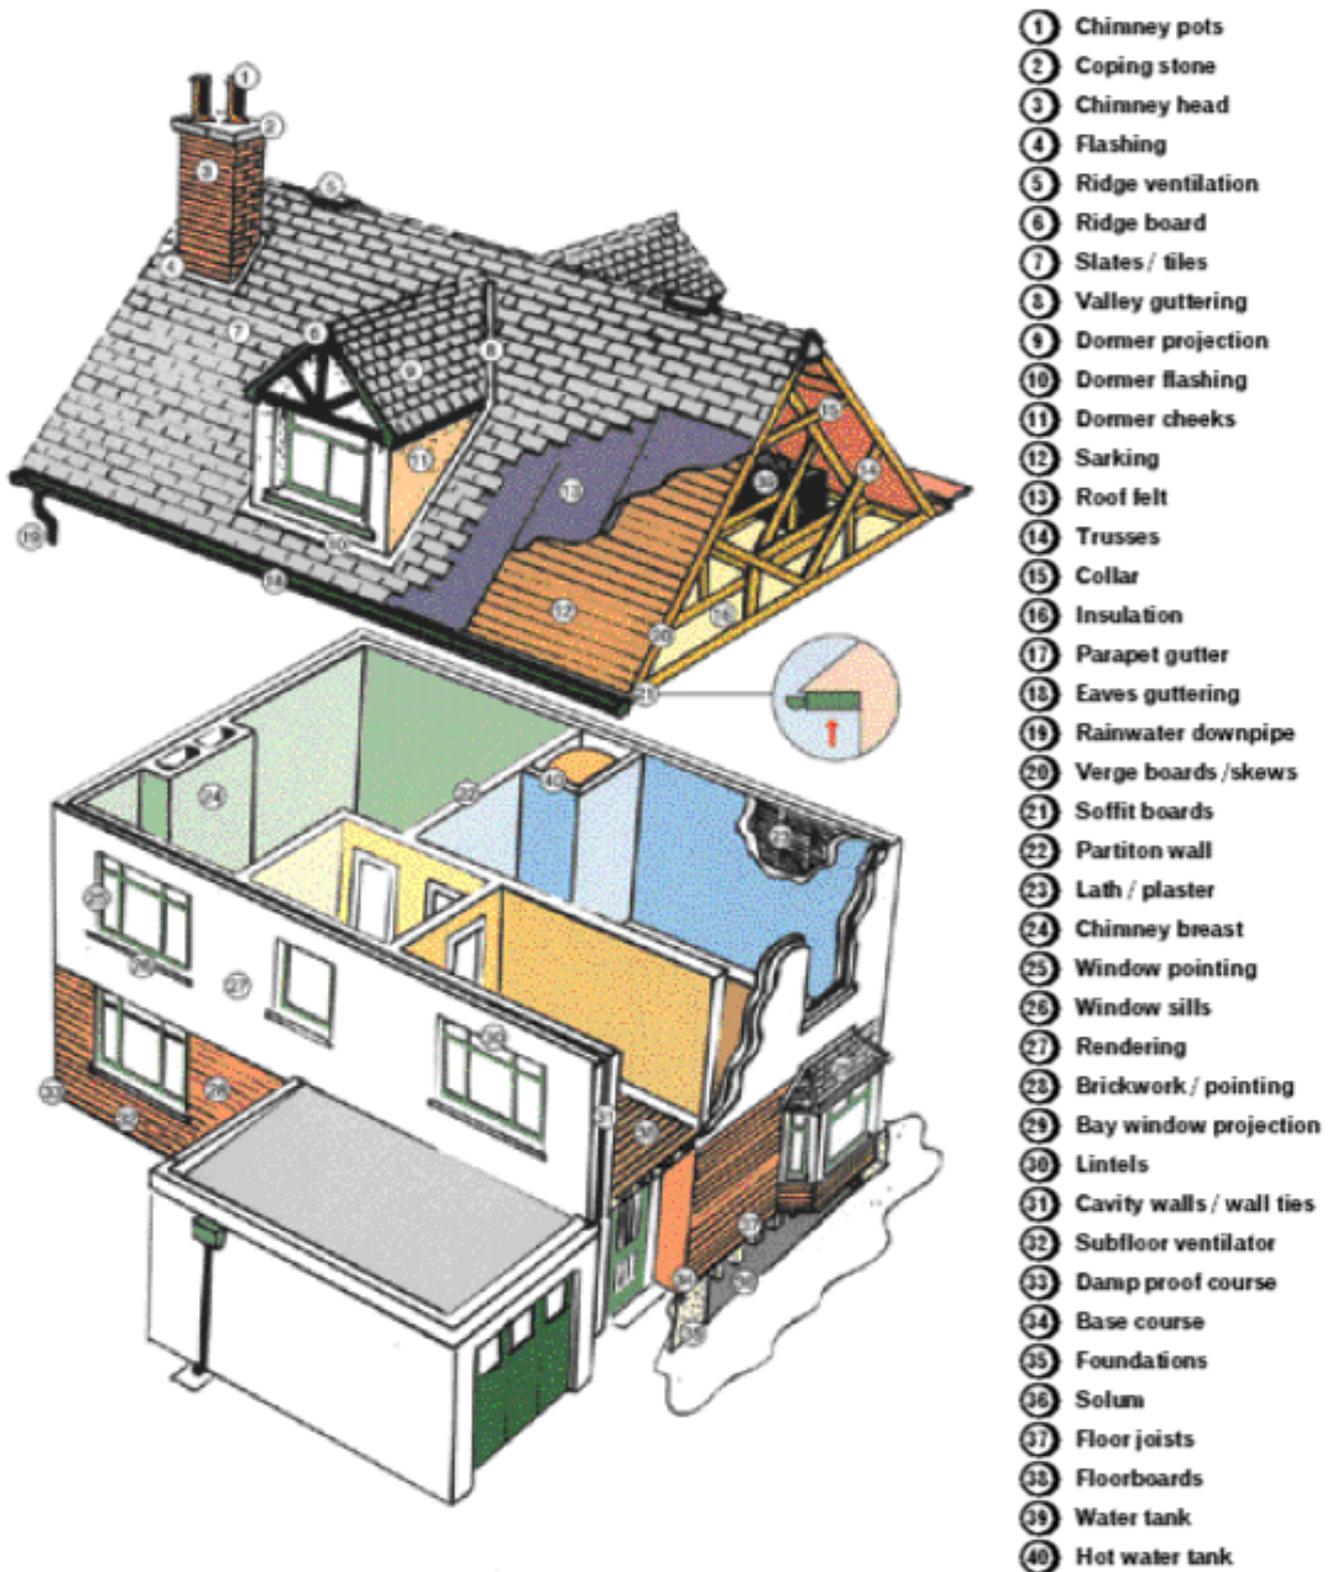
Sectional diagram showing elements of a typical house

Reference may be made in this report to some or all of the above component parts of the property. This diagram may assist you in locating and understanding these terms.

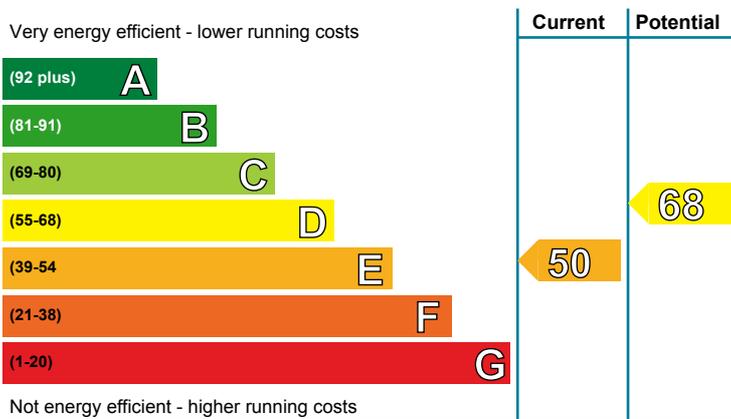
Energy Efficiency Rating

This graph shows the current efficiency of your home, taking into account both energy efficiency and fuel costs. The higher this rating, the lower your fuel bills are likely to be.

Your current rating is **band E (50)**. The average rating for EPCs in Scotland is **band D (61)**.

The potential rating shows the effect of undertaking all of the improvement measures listed within your recommendations report.

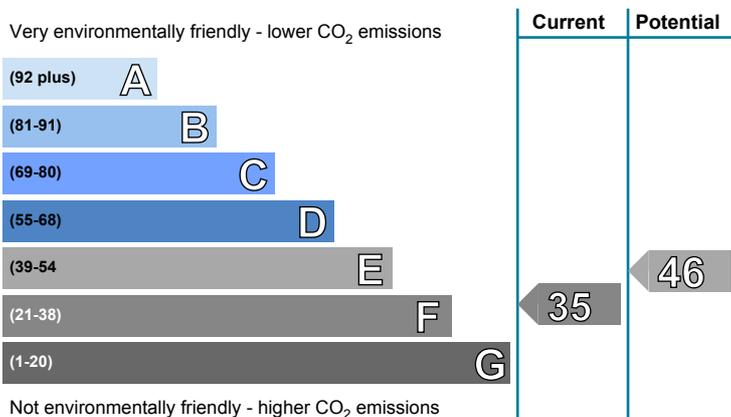
Environmental Impact (CO₂) Rating

This graph shows the effect of your home on the environment in terms of carbon dioxide (CO₂) emissions. The higher the rating, the less impact it has on the environment.
